Case Report - Dr. med. dent. Wolfgang Prinz, MDSc, Switzerland

Biodenta® Tissue Level Implants placed in the atrophic posterior mandible

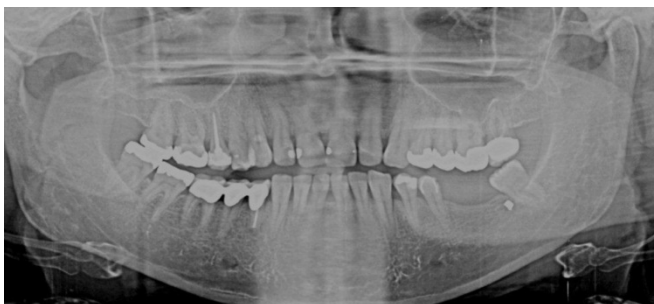
Fig.6: Panoramic radiograph (OPG) taken at first consultation

In the region of the missing teeth 36 and 37, an hourglass defect was visible. For the radiographic examination an OPG was taken (Fig.6).

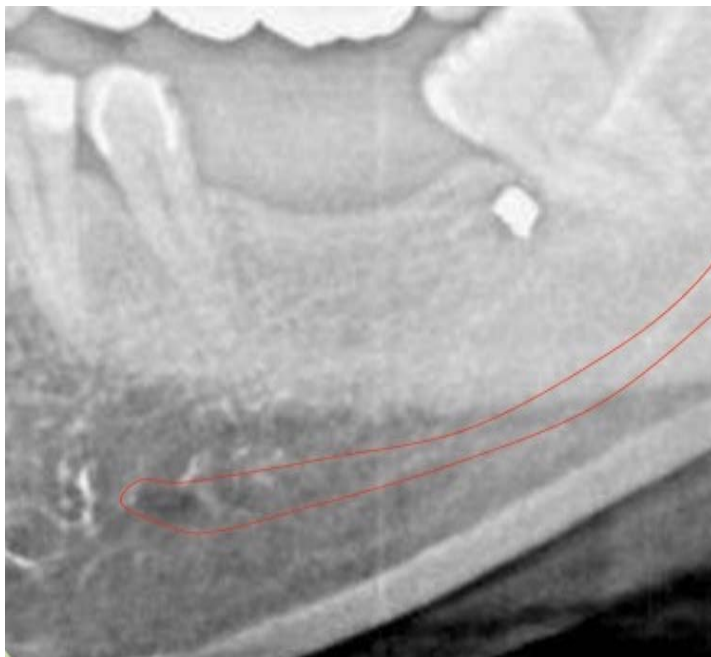
Fig.9: Detailed picture of the panoramic radiograph - mandibular canal outlined

Fig.8:
Intermaxillary relation

- a) The distance to the mandibular canal was 17mm and 15mm respectively.
- b) The roots of the adjacent teeth were not in the area of the planned implants.

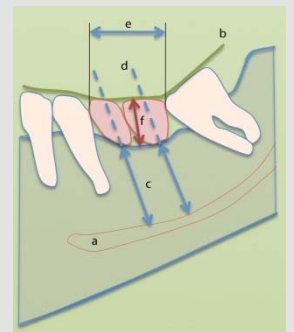
Fig.10: Parameters of the surgical and prosthetic planning:

- a) Course of the inferior alveolar nerve
- b) Course of the Curve of Spee
- c) Distance to the mandibular canal
- d) Ideal insertion axis
- e) Distance between the contact points of the adjacent teeth
- f) Intermaxillary distance

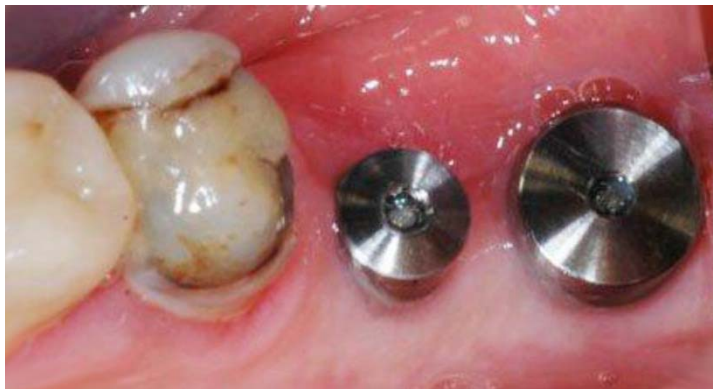
Fig.13: Healing Abutments in situ

After three months healing time, the implants were exposed and healing abutments were inserted.

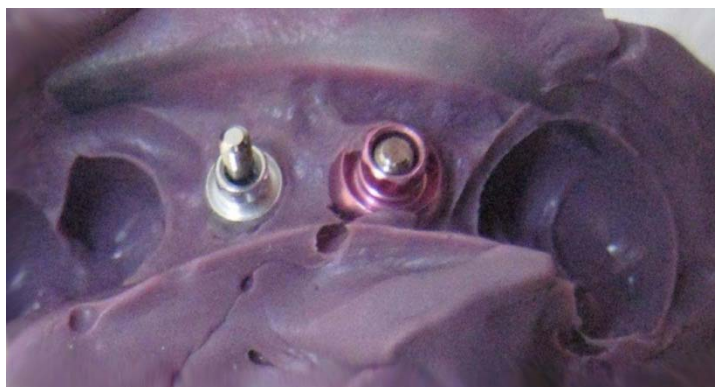
Fig.15: Close-up of the impression

Two weeks later an impression was taken using Impregum[®] impression material and a customised impression tray for a screw retained restoration.

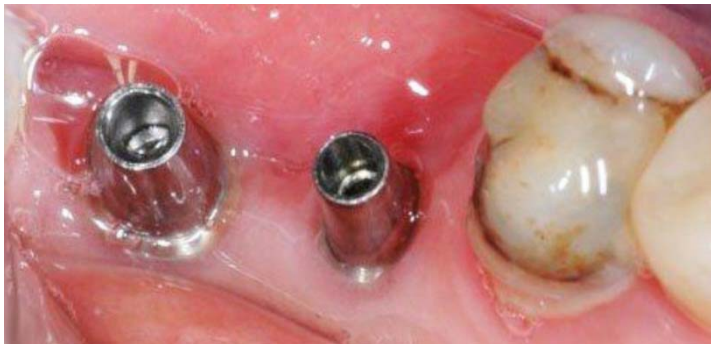
Fig.18: Fitted titanium abutments

Two titanium abutments were fitted with a torque of 35Ncm.

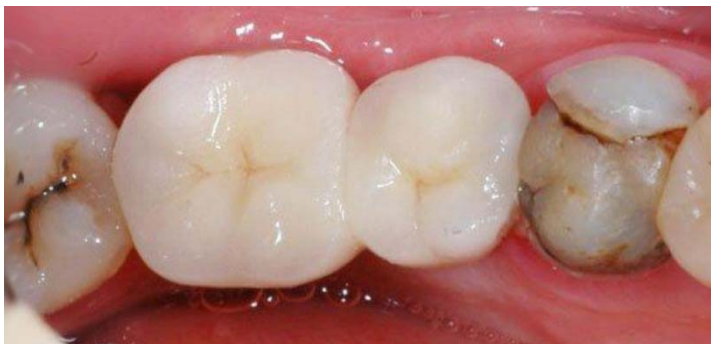
Fig. 20: Occlusal view of the final restorations

For biomechanical reasons, both PFM crowns were splinted together. Space was provided interproximally between both crowns to allow insertion of an interdental brush to enable maintenance of an adequate hygiene protocol. For the cementation zinc phosphate cement was used.
