Case Report - Dr. med. dent. Steffen Ulbrich, St. Gallen, Schweiz

Biodenta[®] Tissue Level Implant – expanding an existing bridge restoration

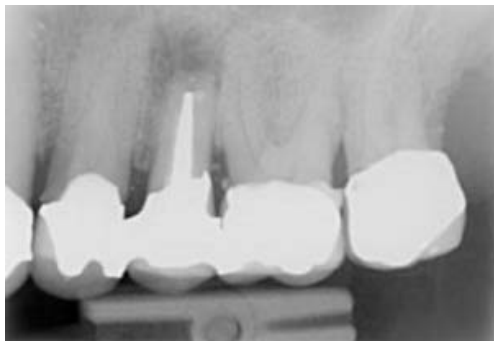
Fig. 5: Close-up of the situation on tooth #25

The periapical x-ray of the maxilla (Fig.5) shows an endodontic post restoration with an apical lesion on tooth #25, whilst Fig.6 shows another infected area on tooth #44. After the extractions and a healing time of 3 months, the post-surgical x-ray showed a stable bone situation (Fig. 2, 3 and 4).

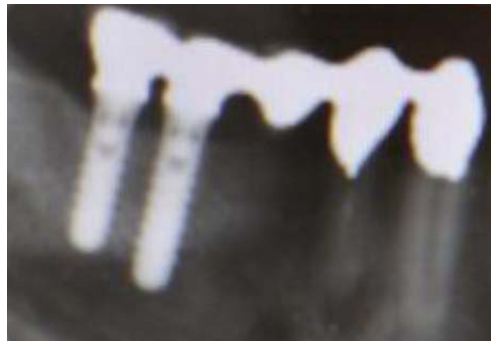
Fig. 6: Close-up of the situation on tooth #44

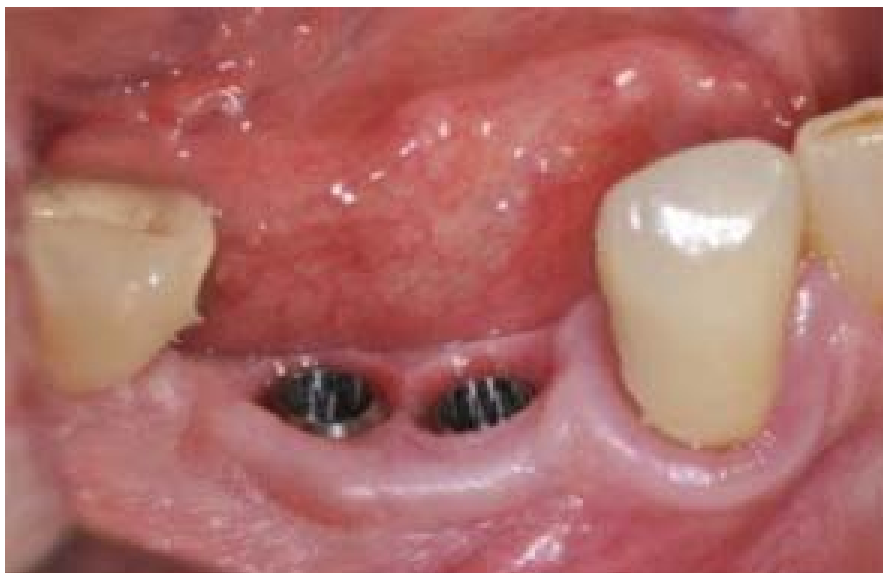
- a. Hidden healing: with this option a closure screw is inserted into the implant and then the soft tissue is sutured over the implant for healing purposes.
- b. Exposed healing: with this option a “healing cap” is inserted into the implant. The height of the healing cap can vary between 2 and 4mm. The soft tissue is adapted to the healing cap and sutured around it. The advantage of this technique is that the soft tissue is “pre-formed” to the shape of the final abutment (Fig.9).

Fig. 9: Pre-formed soft tissue profile.

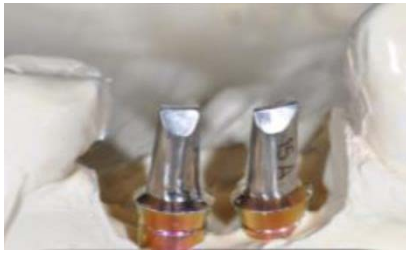
Fig. 10: Customised abutments on the mandibular model

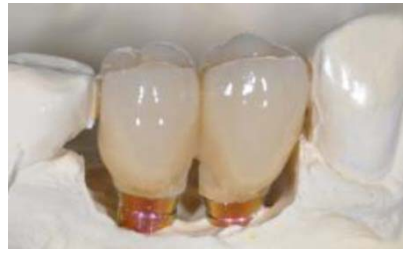
Fig. 11: Final crown restorations seated on the mandibular model

Due to functional considerations, the crowns for #44 and #45 were fused. A chamfer between both crowns enables the insertion of an interdental brush for cleaning the space. Zinc Phosphate cement was used for the final cementation of the crowns.

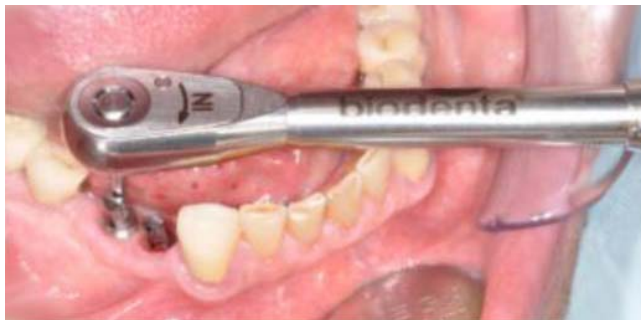
Fig. 14: Torque wrench tightening of a customised abutment

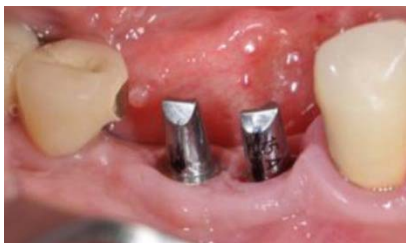
Fig. 15: Fixed customised abutments in the mandible

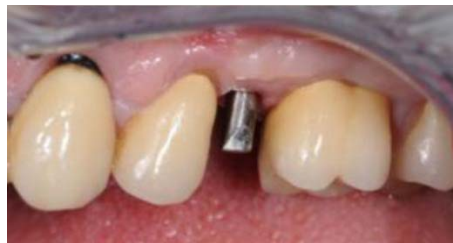
Fig. 16: Fixed customised abutments in the maxilla

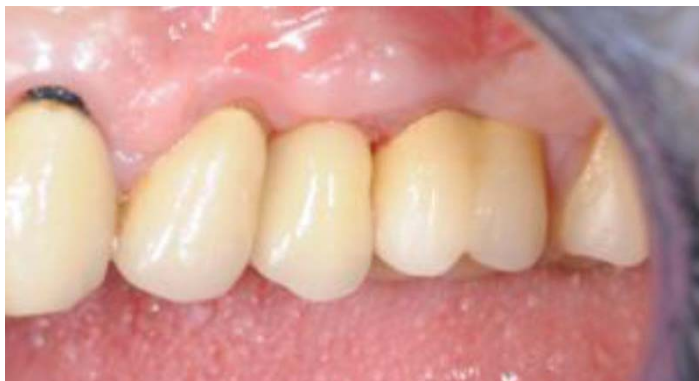
Fig.21: Cemented restoration in the maxilla

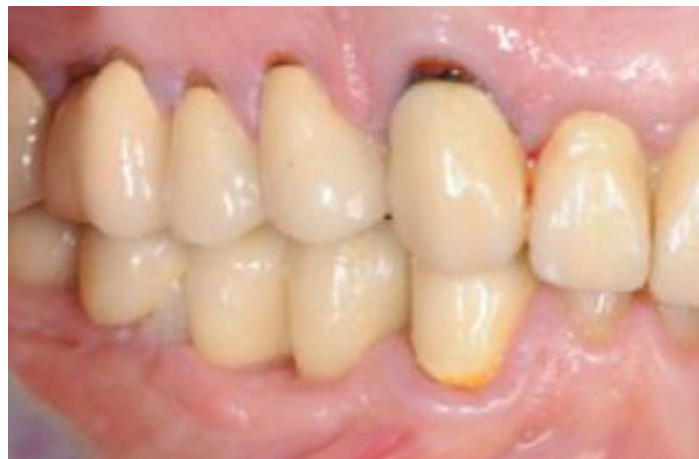
Fig.23: Cemented restoration in the mandible.
